Appendix O

Benthic Video Characterisation

Wafi-Golpu Project

Benthic video characterisation

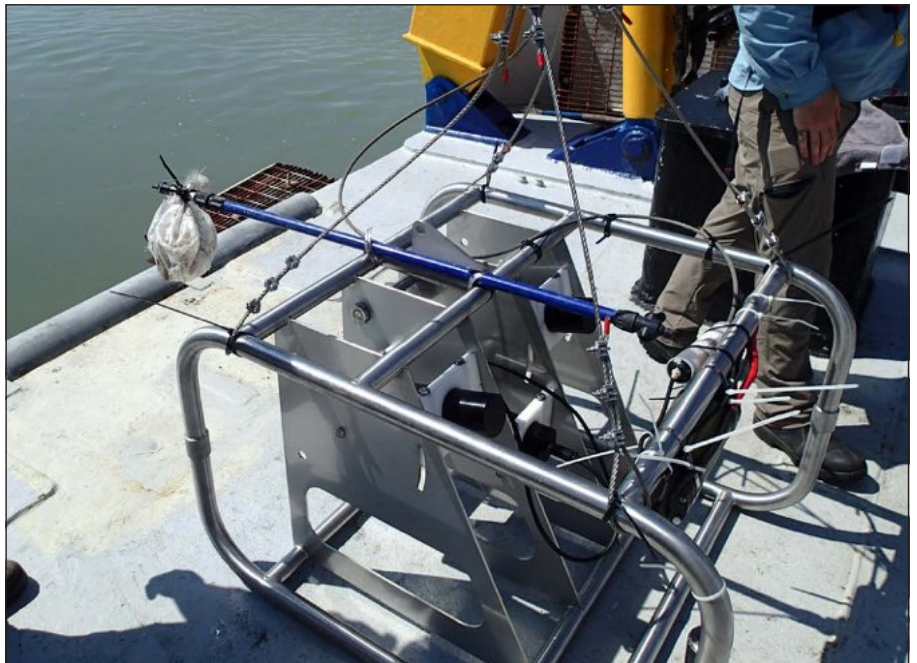
Plate 2.5
Bait bag affixed to UIS during BRUV deployments

The BRUV sample technique was used at Site 6 (a relatively shallow location west of the Markham Canyon near where locals were observed to fish using handlines from outrigger canoes), Site 7 (south of the Markham Canyon and beyond the immediate area of influence of the Markham River plume), Site 8 (a narrow section within the Markham Canyon expected to be heavily influenced by the natural turbidity current), and Site 9 (northern wall of the Markham Canyon). The BRUVs involved mounting a pole to the UIS in line with the centre of the upper field of view of the cameras, and attaching a baited bag (including mackerel and trevally) to the end of the pole, approximately 80 cm from the front of the UIS (Plate 2.5). The BRUV method was intended to record image data of fauna attracted to the bait within the field of view of the camera (Plate 2.6). The longest BRUV deployment was at Site 6 where it was suspended in the water column for 15 minutes at depths of 75 m and 230 m to investigate the likelihood of pelagic fish in the area. These depths corresponded to 155 m and less than 5 m above the seafloor, respectively. After being suspended for 15 minutes the UIS was lowered to the seafloor. The implementation of the BRUV was an opportunistic addition to the main benthic focus of the study. However, associated time and resource constraints precluded extensive BRUV deployment, or its use at all sites.

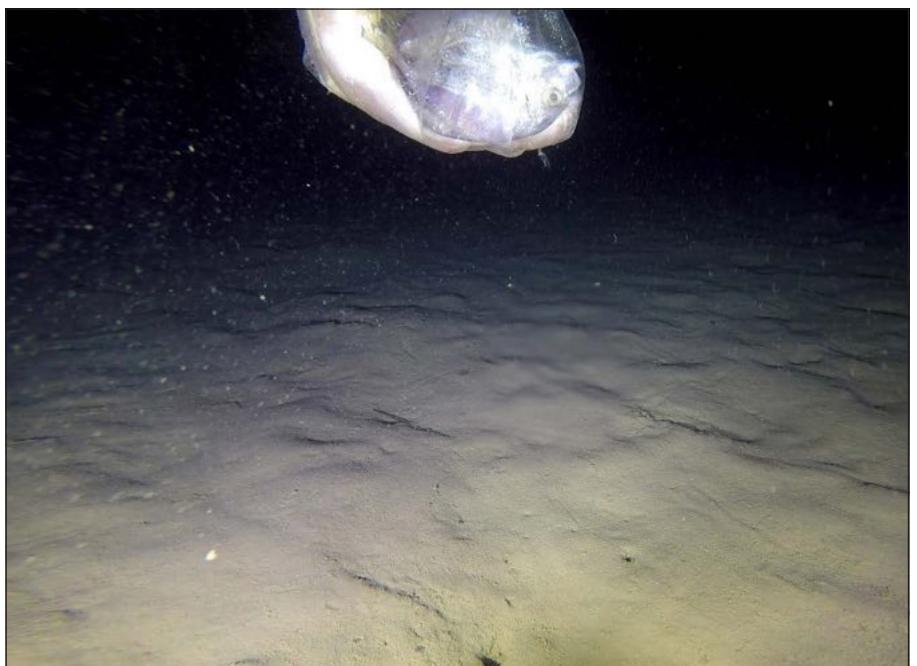
Plate 2.6
Imagery at Site 7 (560 m depth) with baited bag visible. Note burrows in sediment.

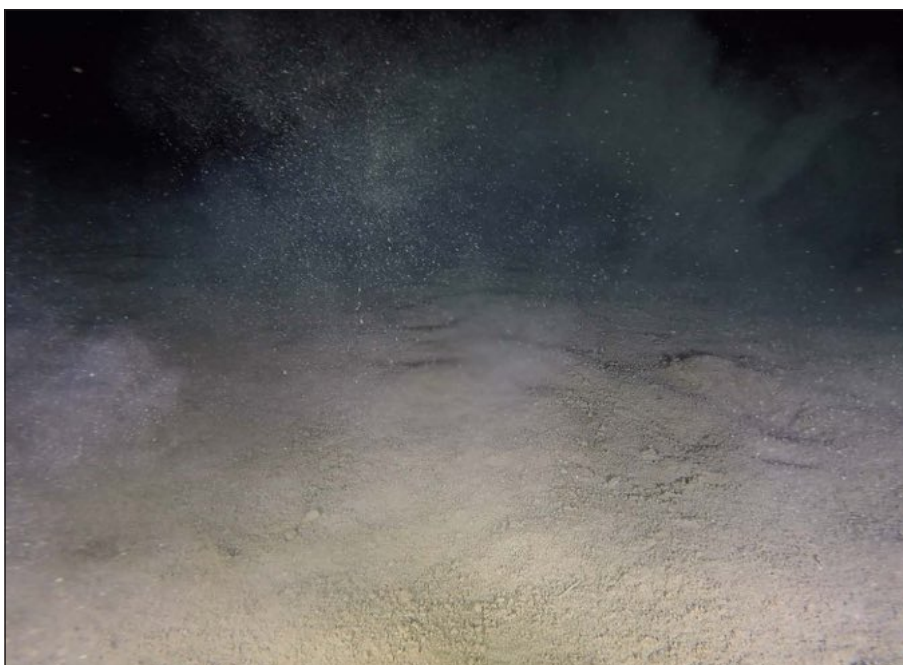
Plate 3.2
Typical seafloor observed across study area

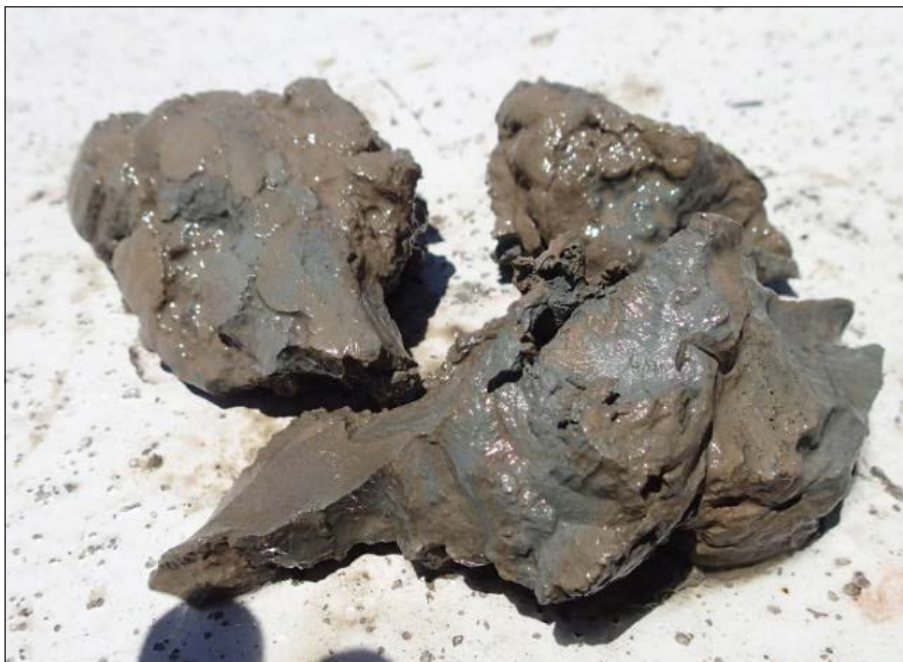
Plate 3.5
Thick brown/grey muddy clay material taken from UIS following deployment at Site 18 (313 m depth)

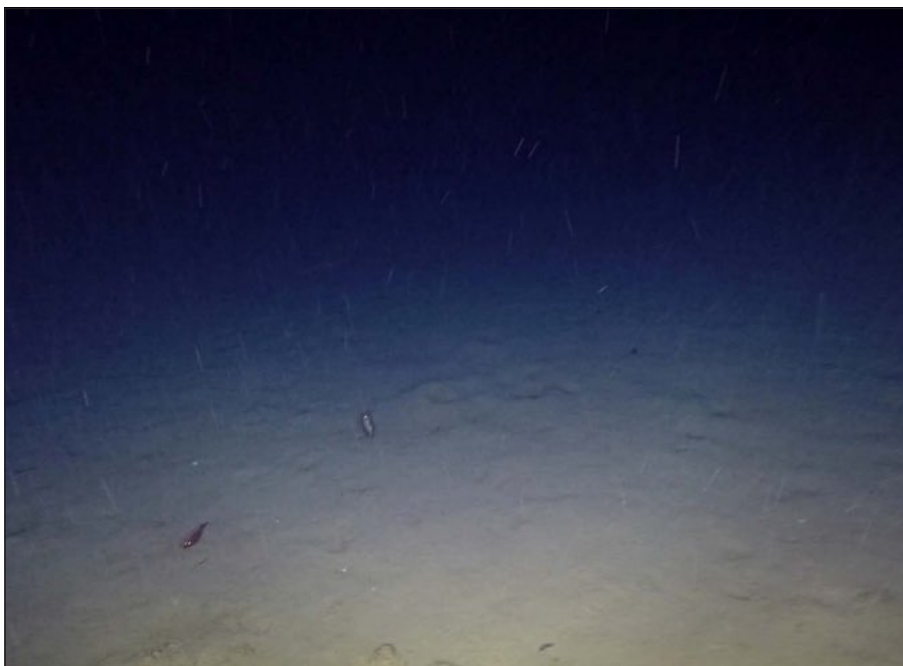
Plate 3.7
Two unidentified shrimp (low centre left of frame)
at Site 13 (757 m depth)

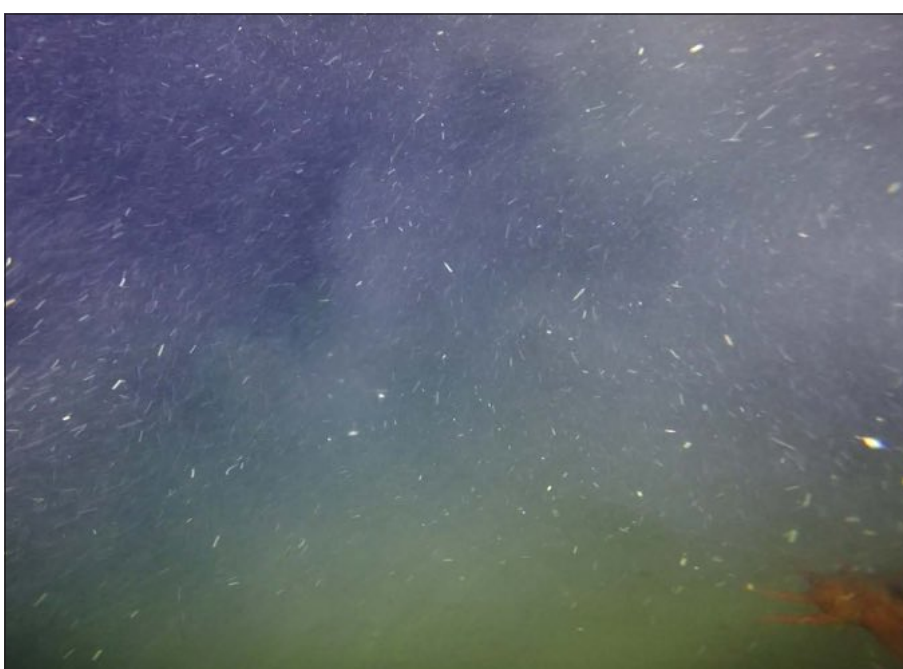
Plate 3.9
Unidentified fauna (Site 7, lower right of frame,
depth 560 m)

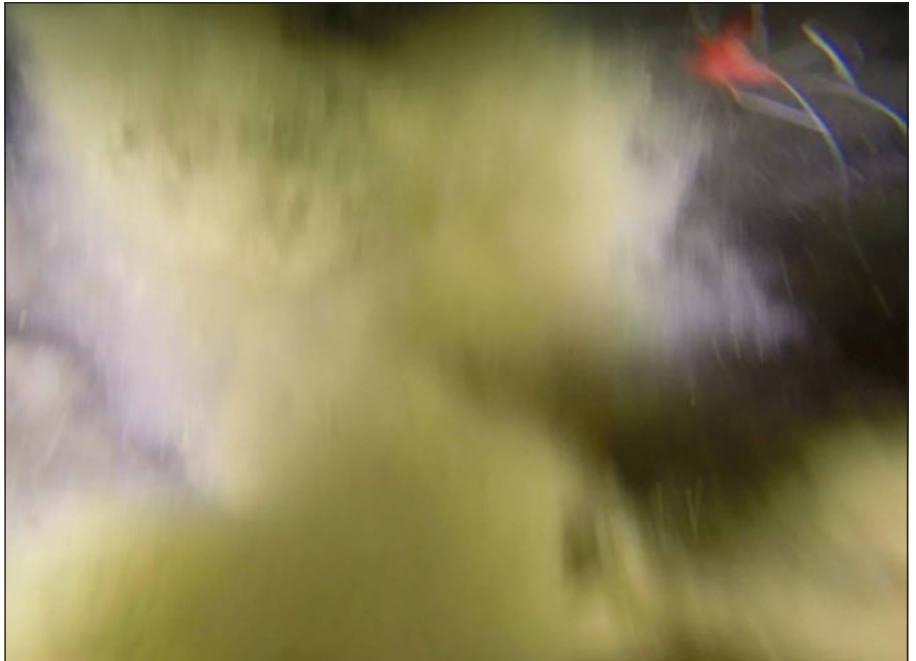
Plate 3.11
Unidentified fauna and resuspended sediment following seafloor disturbance (Site 13, depth 757 m)

Shrimp and other fauna were occasionally observed near the seafloor at sites west and south of the Markham Canyon, including Sites 7, 13 and 14 (Plate 3.11), but could not be identified due to insufficient video imagery resolution and suboptimal perspective. While the image data is unclear and an accurate species identification could not be made, at Sites 15 and 18 the presence of a grenadier fish or rattail of the family: Macrouridae appears likely (see Plate 3.3). Similarly, while accurate identification was not possible, solitary dwarf gulper sharks (possibly *Centrophorus atromarginatus*) appear present at Sites 7 and 15 in imagery captured just prior to UIS contact with the seafloor.
